Diamond-like carbon coatings on medically relevant polyurethane tubing with a follow-up aging study

Christian B. Fischer^{1,*}, Magdalena Rohrbeck¹, Simon Zentgraf¹, Stefan Wehner¹

¹ Department of Physics, IfIN, University Koblenz-Landau, 56070 Koblenz, Germany

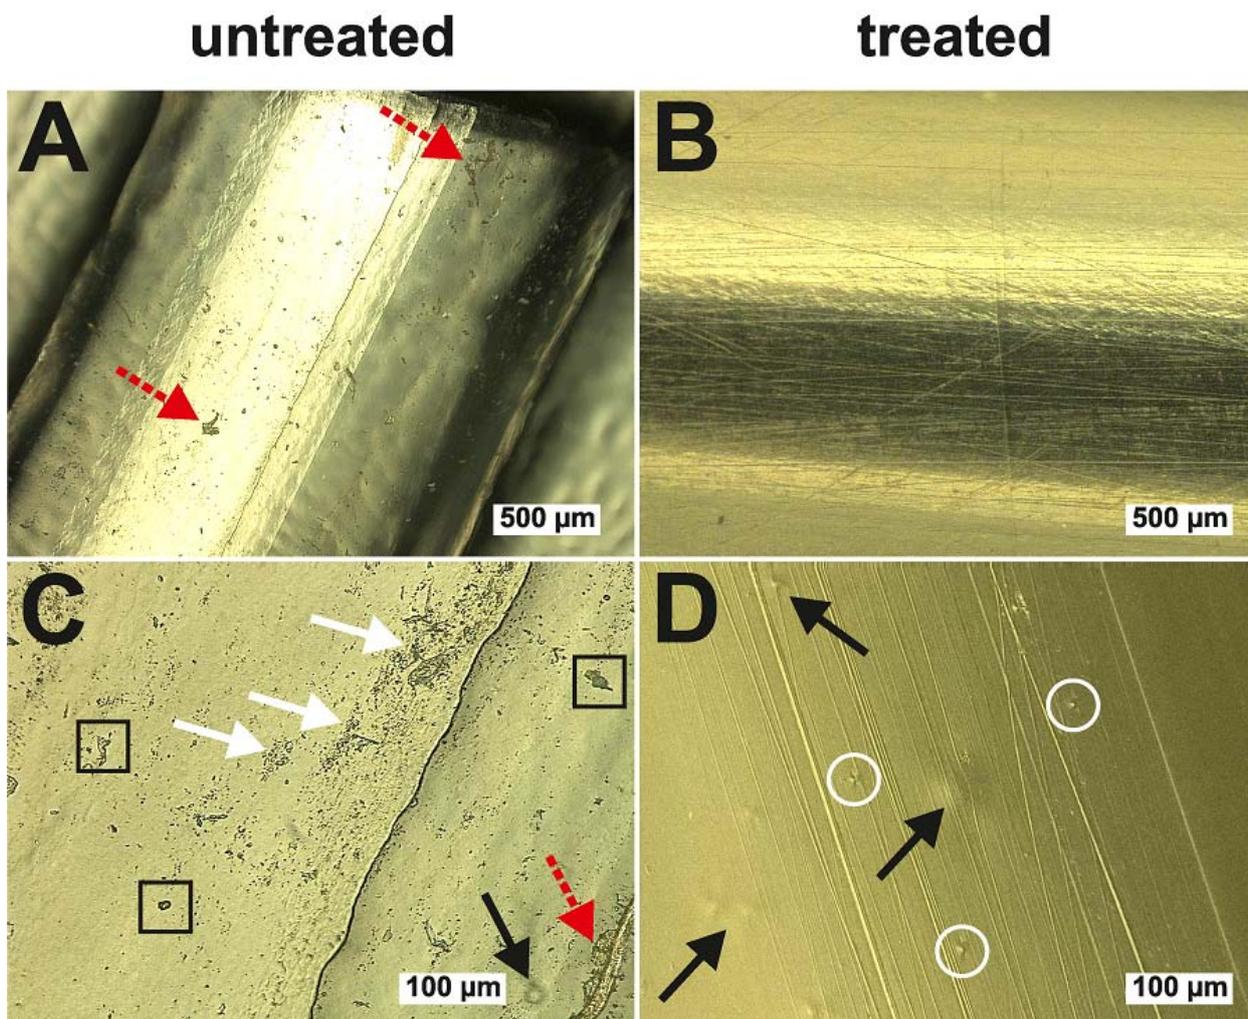
Figure 1. Optical microscopy images of untreated raw PU-tubes (**A** and **C**) and isopropanol treated ones (**B** and **D**) reveal several contaminants (red dotted arrows for packaging material in **A** and **C**, black squares for dust particles and solid white arrows for mineral particles in **C**) and surface characteristics, such as bumps (solid black arrows in **C** and **D**), embedded particles (white circles in **D**) and scratches.

The optical microscopy examination illustrated in Figure 1 shows the surface topography of untreated PU-tubes (Fig. 1A and Fig. 1C). There are packaging residues (red dotted arrows) as well as remaining dust and mineral particles (black squares and solid white arrows, respectively) clearly visible on the unmodified tube. Furthermore, markings caused by the manufacturing process such as extrusion lines and scratches can be seen. Bumps caused by an uneven melting process, indicated by solid black arrows, shine through from below the surface. After the wiping procedure (= treated) the tube is noticeably cleaner, as shown in Figures 1B and 1D. There are significantly fewer dust particles and no remains of packaging material on the cleaned tube. Compared

with the raw material in Figures 1A and 1C even more mechanical damage is detectable in the treated PU-tubing. Scratches are more plentiful in Figure 1B, criss-crossing each other, though shallower, obviously caused by wiping. Bumps (solid black arrows) as well as embedded particles (white circles) are more clearly visible as can be seen in Figure 1D. The cleaning treatment with IPA already shows considerable effects and optical microscopy is sufficient enough to identify macroscopic impurities on the raw sterile tubes very quickly.

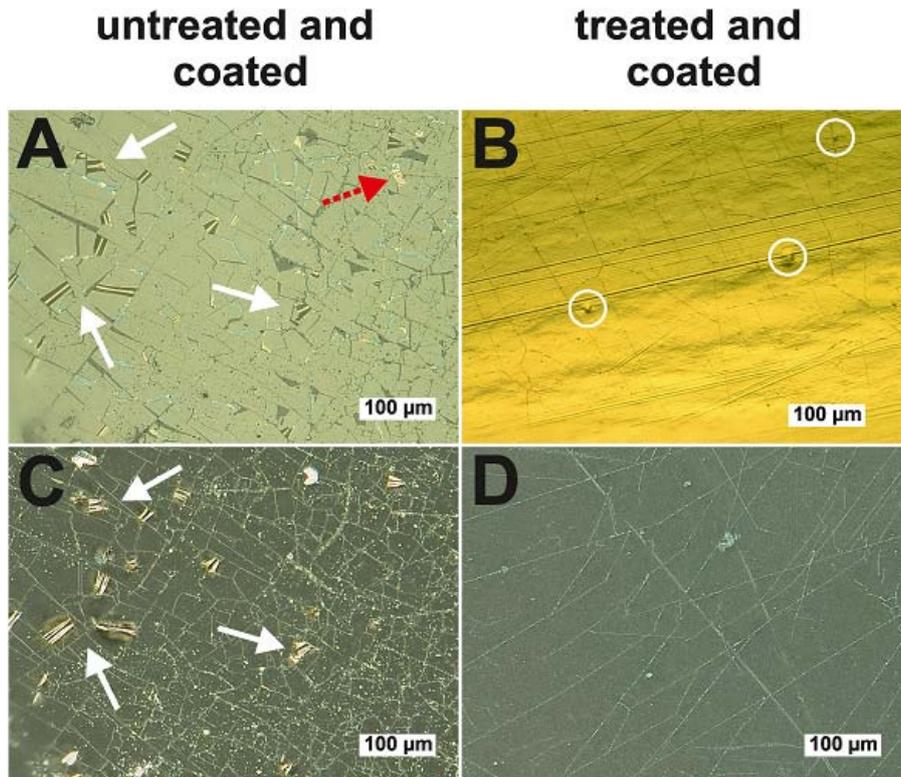
Figure 2. Optical microscopy images of DLC-coated PU-tubes untreated (**A** and **C**) and isopropanol treated (**B** and **D**) display crack lines and surface damage (dotted red arrow for broken-off flakes in **A**, solid white arrows for folding or rolling plates in **A** and **C**) in the DLC-coating. In images **C** and **D** the method of side light illumination is applied for better overview of crack lines and dust particles. The bumps and embedded particles (white circles in **B**) are still detectable although coated with DLC.

Both untreated and treated tubes were coated with 50 nm of DLC. Figure 2 shows images of the respective surfaces using optical microscopy, and the images in Figure 3 are of those using SEM. Both microscopy techniques show folding or rolling plates (solid white arrows in Figure 2A/C and Figure 3A), brittleness and broken-off flakes (red dotted arrows in Figure 2A and Figure 3A/C) indicating areas of the carbon layer with no contact to the PU-material. The optical microscopy image in Figure 2A for the untreated and DLC-coated material shows crack lines with spaces in between. The crack lines as well as remaining dust particles are particularly detectable when the method of side light illumination is applied (Figure 2C). Thin crack lines also appear on the treated and DLC-coated material, as illustrated in Figure 2B/D. However, in comparison to Figures 2A/C, they are fewer and farther between, so the number of plates is significantly fewer and the single areas are larger (see Figure 2D). Bumps (white circles in Figure 2B) are still visible, but smoother. The DLC-coating of the cleaned tube in Figure 2B/D appears to cover the main surface features completely.

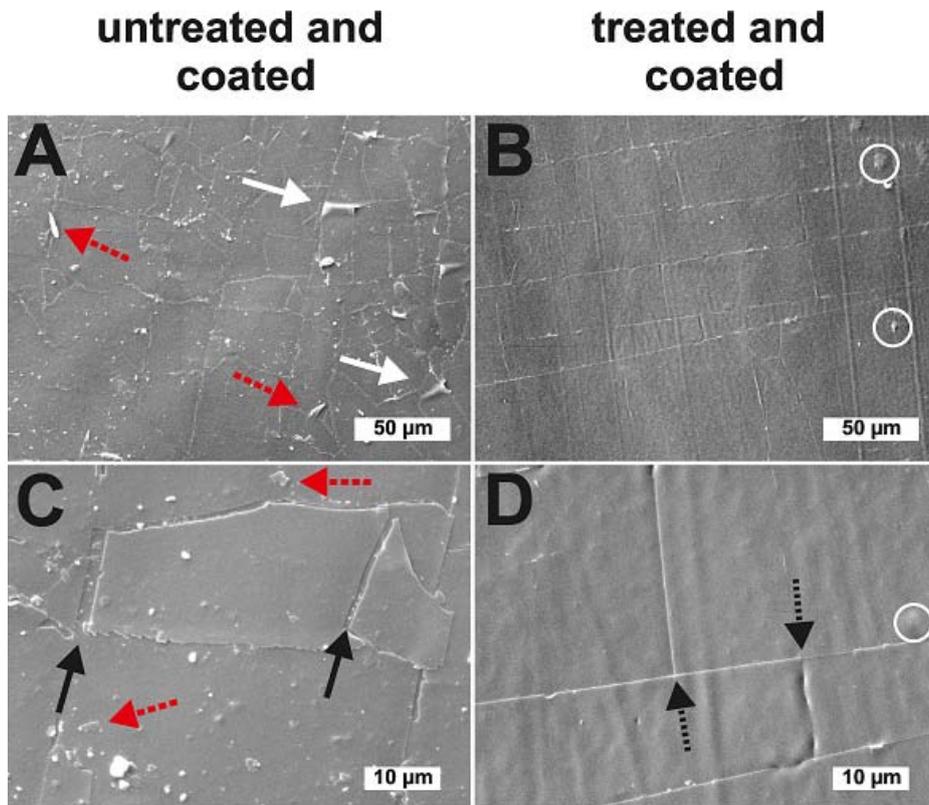
Figure 3. SEM micrographs of DLC-coated PU-tubes untreated (**A** and **C**) and isopropanol treated (**B** and **D**) show crack lines (solid black arrows for cracks with gap in **C**, black dotted arrows for closed crack lines in **D**) and surface damage (red dotted arrow for broken-off flakes in **A** and **C**, solid white arrows for folding or rolling plates in **A**) in the DLC-coating. Bumps of embedded particles (white circles in **B** and **D**) are still detectable in the carbon coating with SEM.

The SEM images in Figure 3 are consistent with these findings. Those of the untreated coated samples (Figures 3A/C) clearly show irregular cracks in the carbon coating. The DLC layer

is breaking off in chunks, displays folded or rolling plates (solid white arrows in Figure 3A) and isolated plates on the surface (red dotted arrows in Figures 3A/C). The material shows a very brittle texture (solid black arrows in Figure 3C) with contaminations of dust particles, which is in line with the findings of the optical microscope (Figures 2A/C). The carbon coating in the SEM-images of the treated tubes (Figures 3B/D) has an overall smooth appearance, still displaying lines and scratches but looking softer due to the coating. Protrusions, possibly dust particles (white circles in Figure 3B/D) seem embedded in the coating. The crack lines are now almost linear, compared to the irregular cracks of the untreated material (Figure 3A/C), and the carbon layer seems to cover them completely undamaged (black dotted arrows, Figure 3D).

The empty spaces of the untreated and coated PU-tubing (Figures 3A/C) indicate brittleness between the carbon layer and the plastic material occurring obviously because of poor adhesion, revealing that no interlayer has formed between these two materials. However, the cleaned tubes show a smooth layer of carbon protecting the parent plastic material fully. This stable covering indicates a strong adhesion to the PU-material with a possible interlayer formation between these two materials.

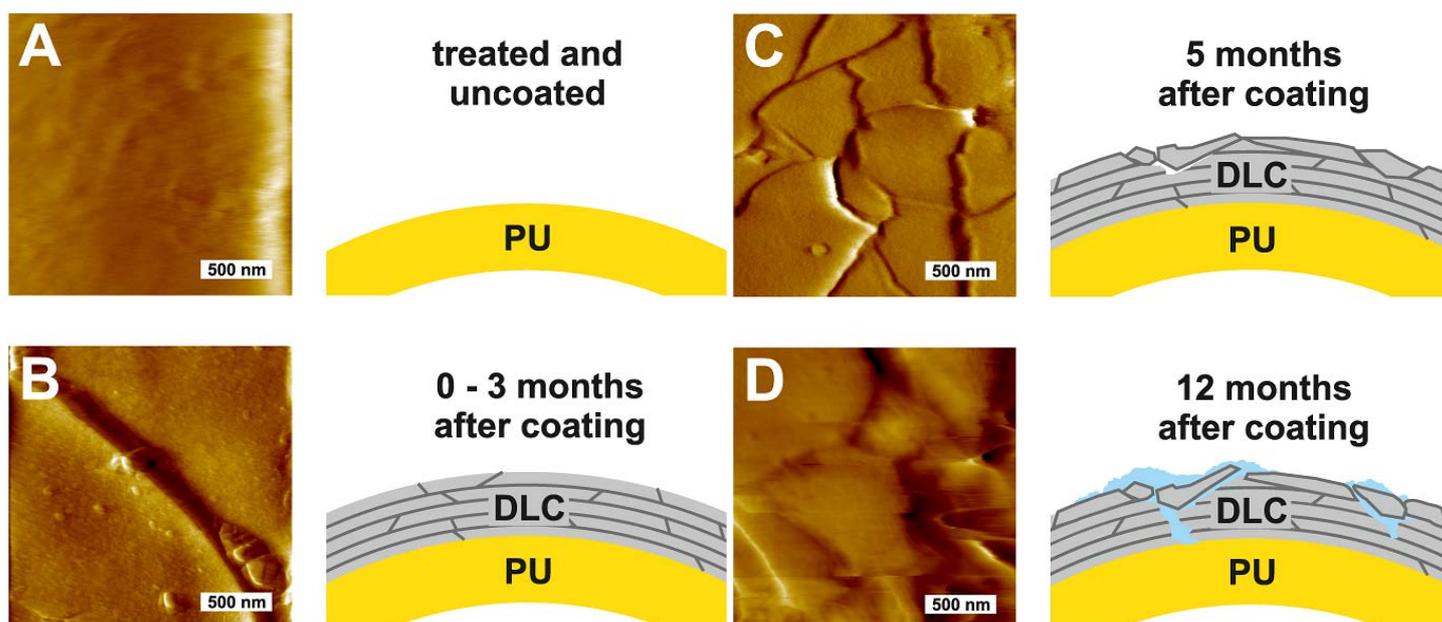
Figure 4. AFM micrographs and diagrams of the PU-DLC material combinations demonstrating the aging process of the DLC-coating on PU-tubes: **A)** treated and uncoated PU-material; **B)** DLC surface up to three months after coating; **C)** DLC five months after coating and **D)** disrupted coating after a period of twelve months.

Atomic force microscopy was chosen for the aging study because SEM-images required a thin conductive layer of gold and it was important to have an uncontaminated surface. Furthermore with this technique it is possible to reveal even smallest changes of the surface morphology in detail due to its small impact and high resolution. Figure 4A displays the topography of a treated PU-tube. The overall contrast in this image is very poor and consistent with the behavior of soft plastic material. There are no significant markings detectable except some presumable bumps or soft irregularities. The diagram on the right shows the profile of the parent PU-tubing with a clean surface (Figure 4A).

The carbon coating on treated material (Figure 4B) shows excellent contrast and reveals significant details after an aging period of up to three months. In the middle of the DLC layer a crack line is visible, possibly due to internal stress or a boundary line between two DLC-plates (Figure 4B). This probably indicates internal material stress or drift especially for the top DLC-layers. Nevertheless, the coating remains entirely on the plastic material because the gap is still filled with carbonaceous material. Adjacent to the plates and on their surface small grain-like spots are visible. The diagram on the right in Figure 4B shows the layered structure of the DLC-coating on the PU-plastic material. Cracks or boundary lines were drawn between the layered structures illustrating the response to internal material stress.

After an aging period of five months, overlapping flakes become detectable within the same scale of area (Figure 4C). At this stage the DLC-coating has obviously broken down and shows an overall brittle appearance. The cohesion of the carbon layer is lost and the overall surface structure appears like ice floats. The diagram in Figure 4C illustrates the damaged top DLC-layer. The lower carbon layers, however, are most likely still intact and protecting the parent PU-material, because the situation completely changes after a period of 12 months.

In Figure 4D there are still plates recognizable but with 12 months of aging the carbon coating has completely collapsed. Remaining plates are hard to identify and appear like swimming ice floats. The gaps are widely opened and there is no longer contact between the plates. The entire image has poor contrast and shows numerous artefacts. This may arise due to the appearance of

humidity either from ambient conditions or from the parent PU-material, which can contain water and/or additives for flexibility [21]. Even if adhesion between the carbonaceous material and the PU-plastic right after the coating was good because the water film had been removed by the oxygen plasma, incorporated substances may migrate to the tubes surface and damage the coating. Water can also be attracted from surrounding air and penetrate the gaps between the plates and the DLC-layer deteriorates (Figure 4D). The carbon layer has completely broken down; there is no longer protection of the plastic material. Water and other contaminants can now penetrate the carbon layer very easily from either direction. The diagram illustrates the broken down carbon layer and the lack of protection of the plastic material.
